**BUILDING SURVEY**

# Example Property

James Brook BA (Hons), MSc,  
MRICS

Friday 17th May 2019

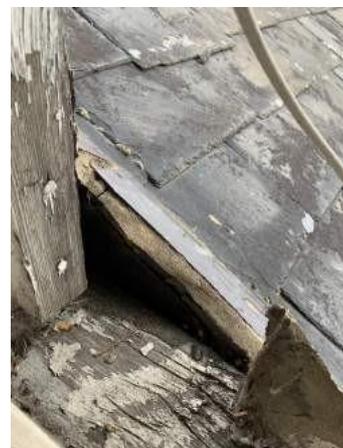
Photo 16 - Cracked slate fillet

There is a slate/cement fillet at the junction of the rear addition roof and rear wall. This is rather cracked and in poor order, particularly around the rear window and we would recommend that this is stripped and replaced with a proper lead flashing in the short term at an approximate cost of £500 plus access. This could lead to damp if left.

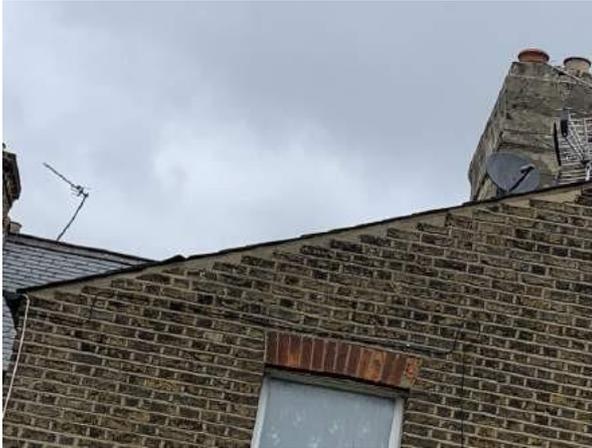
Photo 17 - Cracked dry verge

The dry verge to the edge of the rear addition roof line is cracked in areas and we would recommend that this is re-bedded in cement or a maintenance free UPVC dry verge system installed in the medium to longer term at an approximate cost of £500.

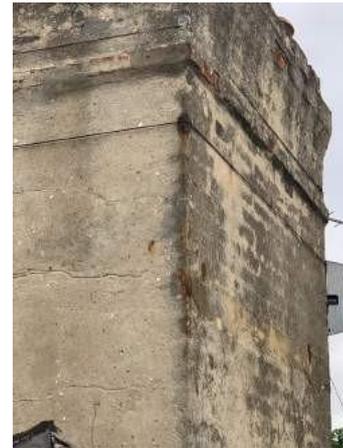
Photo 25 - Cracked and missing render

The render to the rear addition chimney stack is badly weathered, cracked and missing in areas. Some of the brickwork is also cracked and loose. We would recommend that the old render is hacked off, the underlying brickwork repaired and the chimney stack re-rendered at approximate cost of £1000-£1500 plus access.

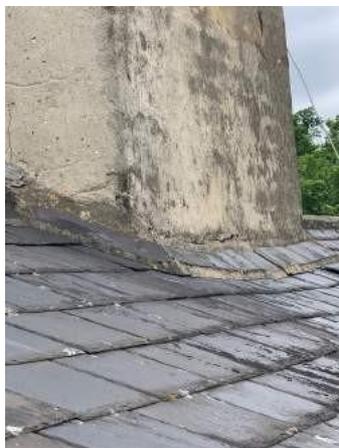
Photo 26 - Poor flashing

The slate fillets around the junction of the chimney stacks and roofs are weathered and cracked and will not prove to be sufficient. These will be a point of vulnerability to damp ingress, if this has not already occurred. We would recommend that the fillets are stripped and replaced with a proper lead flashings in the short term alongside at an approximate cost of £1000.

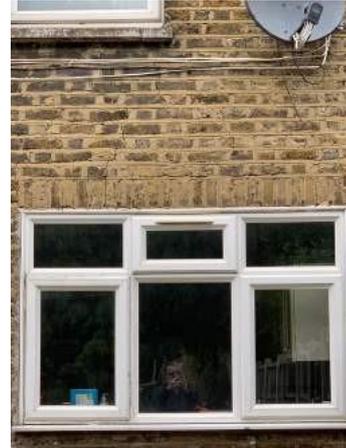
There are signs of cracking above of the rear kitchen window opening and first floor window. The masonry above windows and door frames of older properties such as this one tend to be supported by the original joinery of the framework and often there is no proper lintel. If windows and doors are replaced then a proper lintel should be installed to support the brickwork above. This does not appear to be the case here. Alternatively if there is an original lintel above the window this could be decaying. There are signs that the brickwork is sagging and cracking above the windows, this indicates that the lintel is failing and we would recommend that the installation of new lintels will be required at an approximate cost of £2000 each. The structural engineer should report on this alongside the other items above.

Photo 45 - Failed lintel

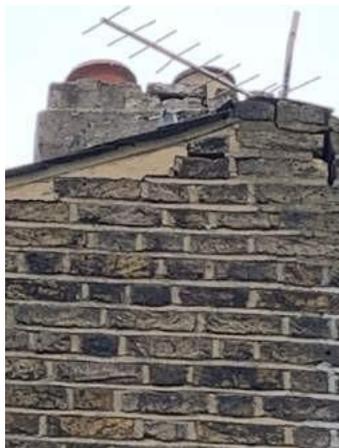
The external mortar pointing is also cracked in a number of areas, most notably below the rear addition roof line and some localised re-pointing to external areas will be necessary, with more extensive re-pointing necessary in the longer term.

Photo 46 - Cracked pointing

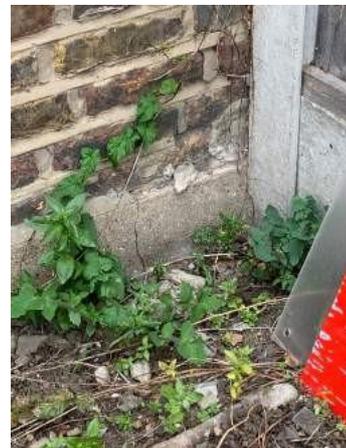
The rendered plinth along the base of the walls is cracked in areas and this may allow moisture penetration via capillary action. This should be repaired or replaced in the short term.

Photo 47 - Cracked plinth

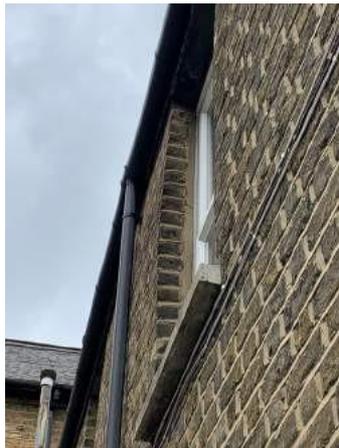
It would appear that the first floor rear addition window arches and lintels have been removed as part of the double glazing installation. This has resulted in the brickwork around the rear addition first floor window openings bulging outwards slightly and this has caused cracks and gaps between the window frames and walls. We therefore believe it likely to be necessary to replace the window lintels here as well as undertaking some repairs to the bulging brickwork. We also noted some further cracking and distortion internally to the rear bedroom walls. We would advise that you instruct a Structural Engineer to undertake further investigation to report on the movement and specify the exact remedial works required. We can see that a concrete lintel has already been installed in the past to the rear middle bedroom.

Photo 48 - Bulging brickwork

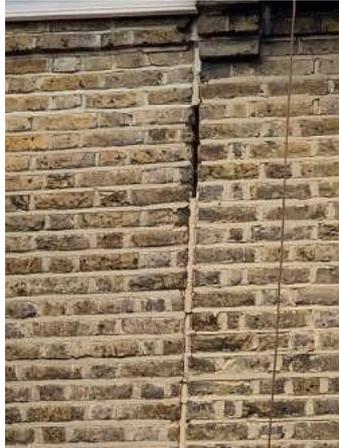
There is a cement fillet between the neighbouring right-hand side property and this is cracked and missing to the rear which should be filled-in in the short term to prevent damp ingress.

Photo 50 - Cracked fillet

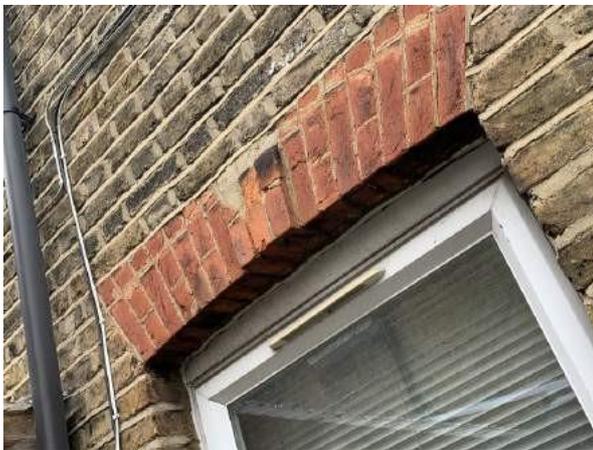
Some of the soft red brickwork above the window arches is badly weathered, spalled and eroded in a few areas and some localised repairs here will be necessary.

Photo 52 - Spalled

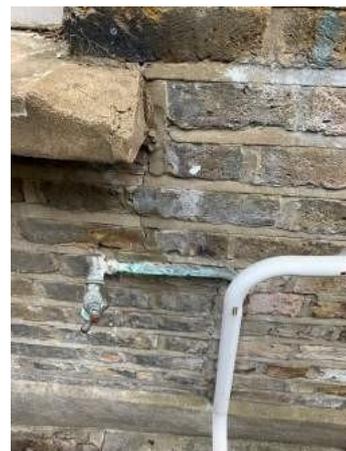
There is some minor cracking to the brickwork and mortar pointing externally. We do not believe this to be serious and is likely the result of historic settlement and normal thermal expansion. The walls should be monitored and repaired as part of the normal maintenance works. The cracking is likely to reoccur over time.

Photo 55 - Minor cracking

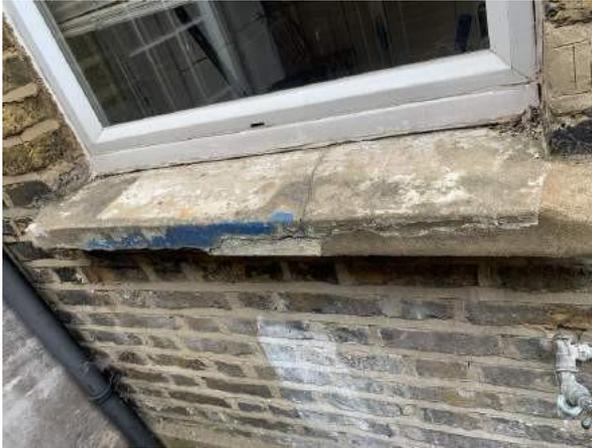
There is weathering and cracking to a number of the masonry window sills and these should be filled in and redecorated in the medium term.

Photo 56 - Cracked sill

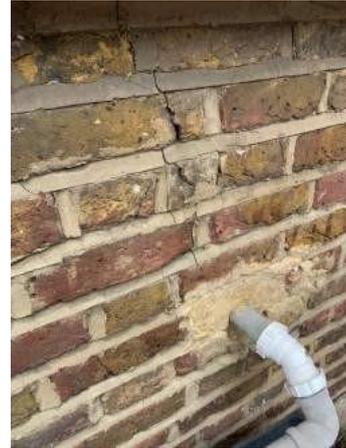
Photo 57 - Cracking to pointing and brickwork

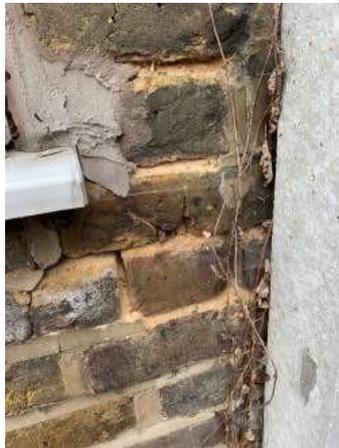
Photo 58 - Missing mortar pointing

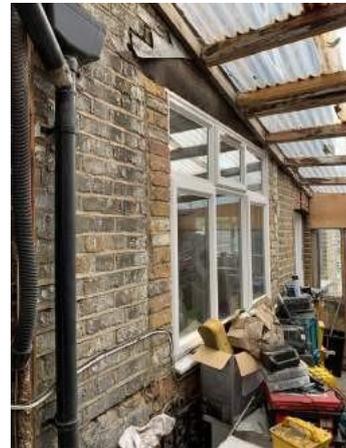
There was originally a bay window to the side of the rear addition which has since been replaced and infilled with brick and a double glazed window panel. The workmanship is rather poor, there is an exposed bitumen sheeted section where the original pitched roof to the bay would have been. The brickwork is cracked and untidy. The exposed section is causing internal dampness. There is likely to be no adequate lintel support above the window openings. We would recommend that this whole section is removed and rebuilt up to proper standards. This work is likely to be extensive and expensive in the region of £2000-£4000 but you should obtain quotes for these works.

Photo 59 - Bay removed

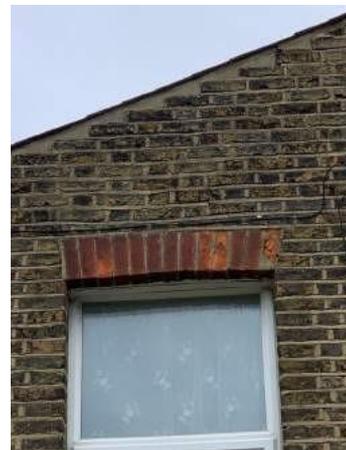
Photo 65 - Cracking above window

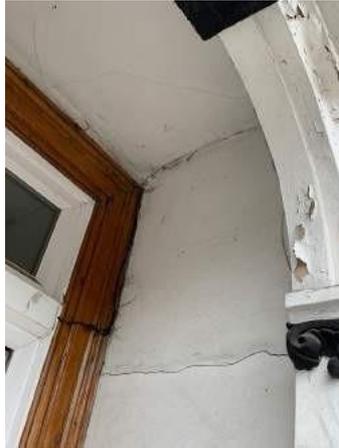
There is some cracking to the front door rendered reveal and it should be filled in and redecorated.

Photo 68 - Cracking to rendered reveal

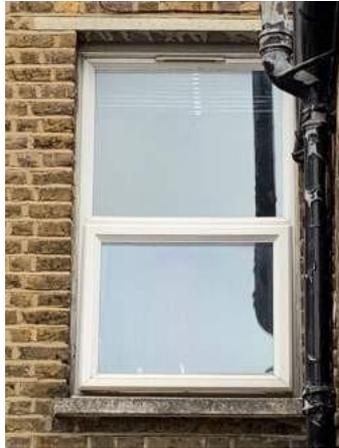
Photo 72 - Misting

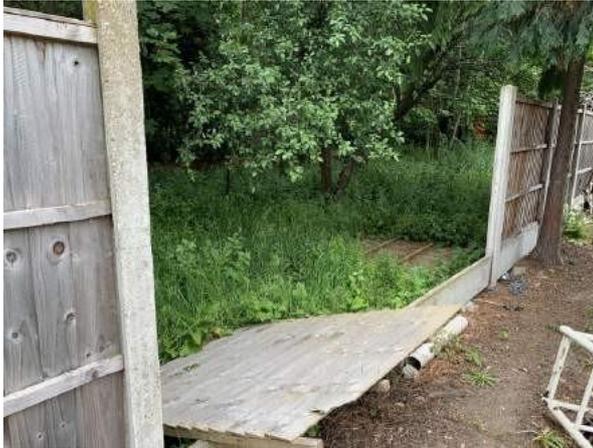
Photo 94 - Missing fence panels

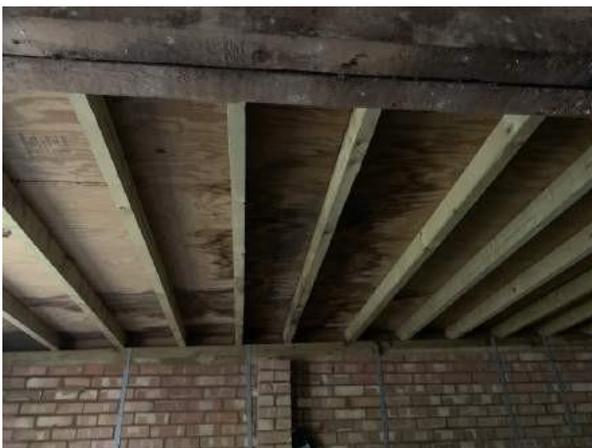
Photo 107 - Damp staining to roof deck

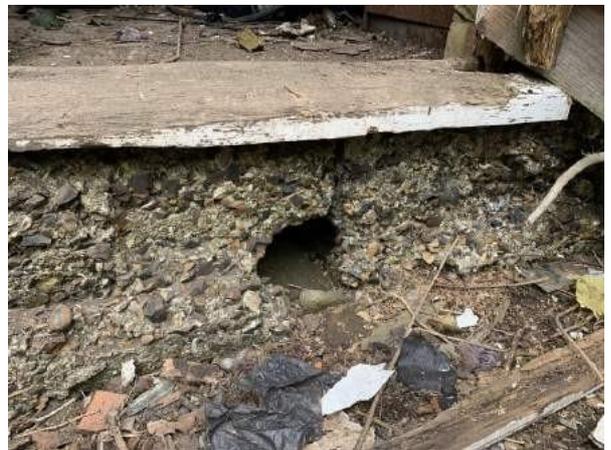
Photo 112 - Cracks to foundation slab

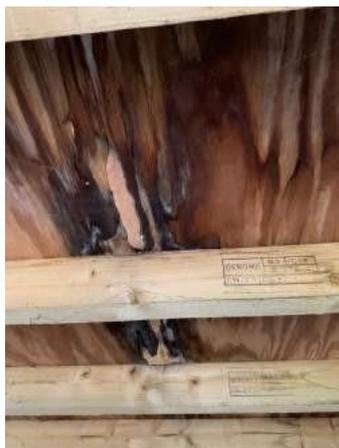
Photo 119 - Rot

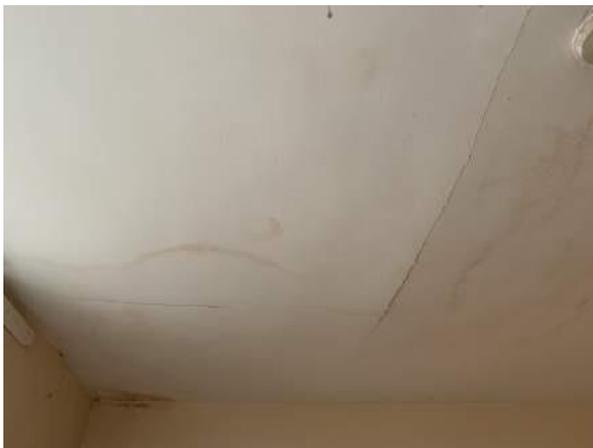
Photo 130 - Damp and cracking

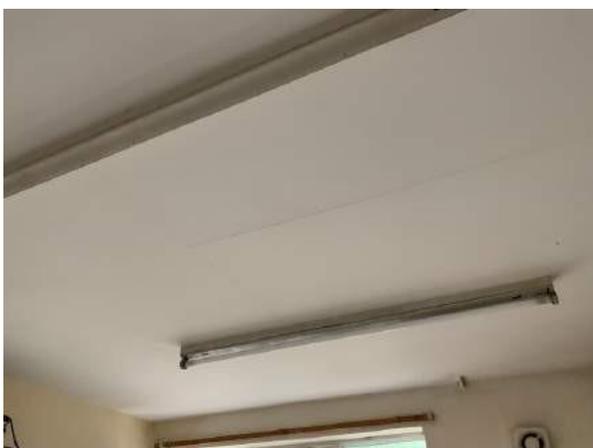
The plasterboard ceilings are also badly cracked and should be re-plastered.

Photo 132 - Cracking to plasterboard

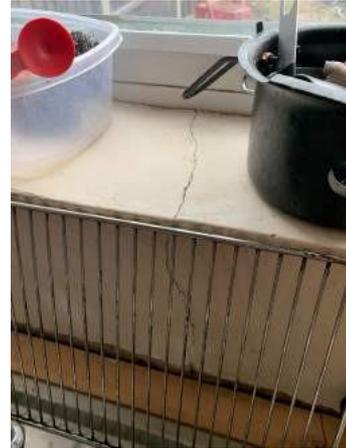
Photo 142 - Cracked plaster

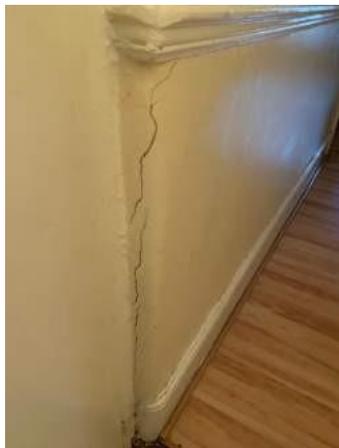
Photo 143 - Cracking

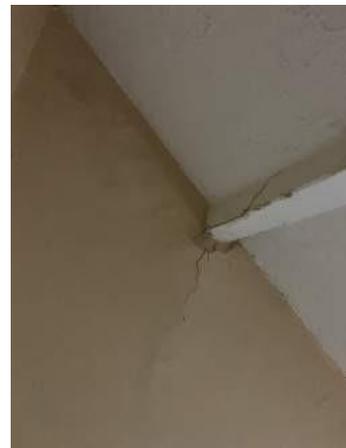
There is some staining and blown plaster to the loft conversion stairwell wall and roof timber. However this area appeared dry when tested with a moisture meter and should be re-plastered and redecorated.

Photo 144 - Damp staining to stairwell.

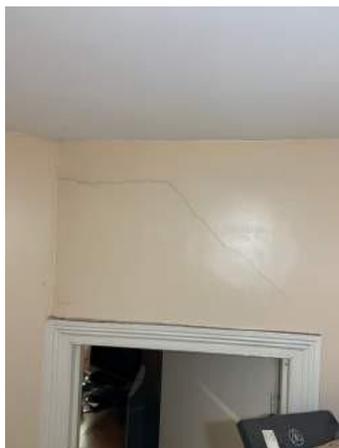
Photo 145 - Cracking

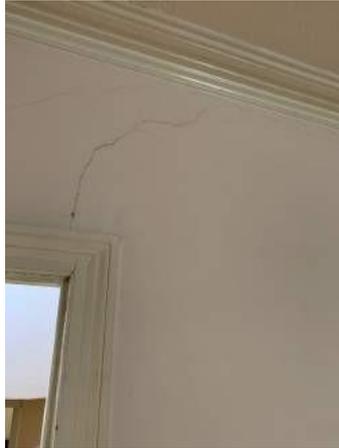
Photo 147 - Cracking above removed partition

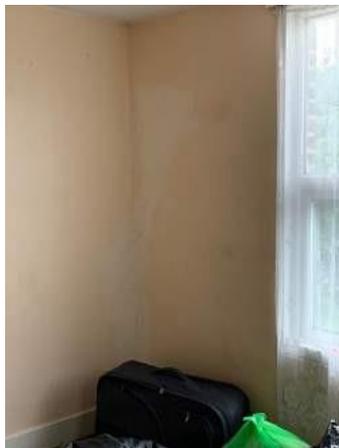
Photo 149 - Significant Cracking

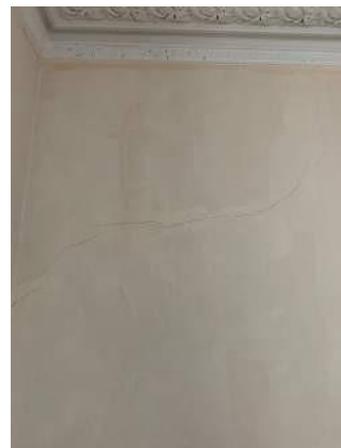
Photo 152 - Cracked plaster

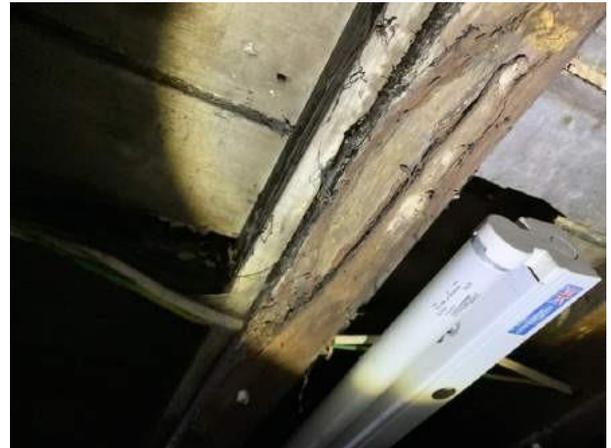
Photo 162 - Rot and decay to floor

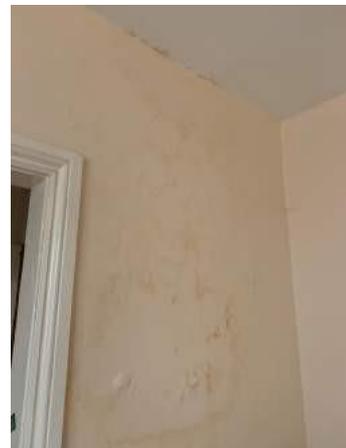
Photo 183 - Damp- leaking pipe

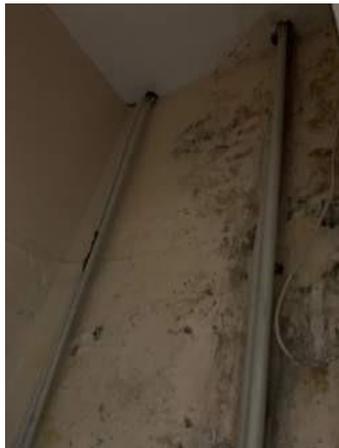
Photo 184 - Damp- leaking pipe

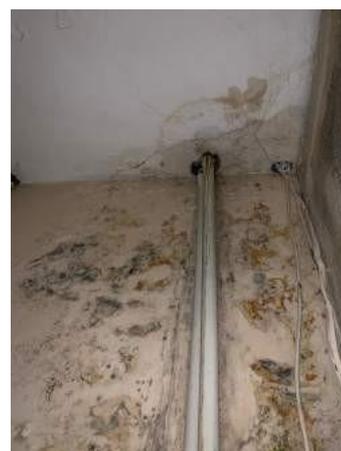
Photo 212 - Leaking pipe

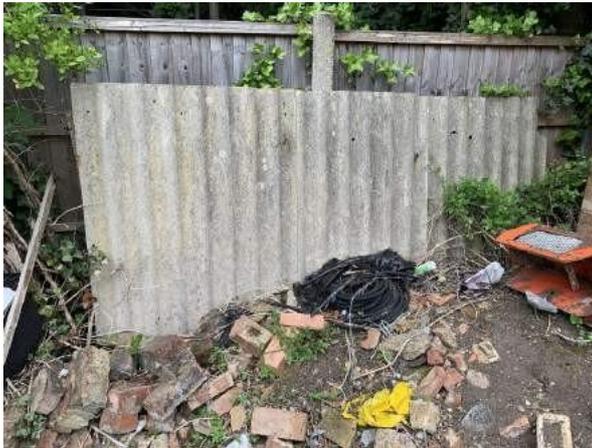
Photo 219 - Asbestos sheets

The presence of asbestos would not normally constitute a hazard unless the material which contains asbestos is disturbed, drilled or damaged. When maintenance work, building improvements or alterations are undertaken, you should therefore be mindful of the possibility of asbestos and the need for a licensed contractor to remove and dispose of any asbestos found which could be costly.
