**BUILDING SURVEY**

# Example Property

James Brook BA (Hons), MSc,  
MRICS

Friday 17th May 2019

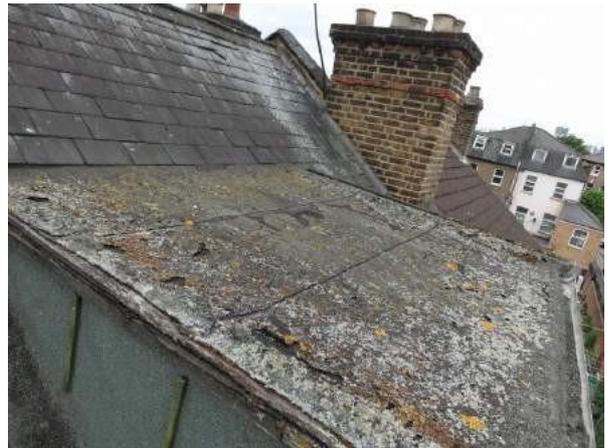
The felt dormer is badly weathered, dilapidated and in poor order. It is highly likely that the poor condition of the felt will have resulted in damp, decay and rot to the timber structure of the dormer and surrounding interior areas. The external joinery is badly rotten in areas. We would recommend that the felt is stripped back and the timbers exposed to inspect their condition. It is likely that replacement and re-covering of the dormer will be necessary, but until these areas are exposed it is not possible to quantify the extent and cost of these works. We understand you intend the re-configure this dormer.

Photo 9 - dilapidated dormer

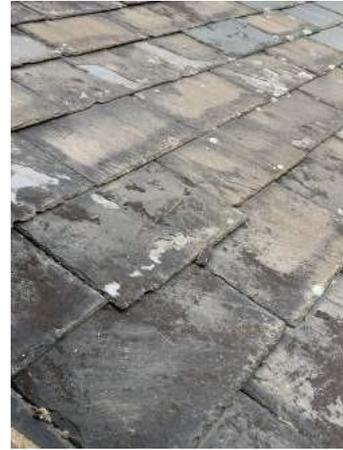
A number of the slates are cracked and slipping and some have been re-fixed with metal tingles. The slates are rather old, weathered and delaminating in areas. These appear to have been coated with a tar-like coating likely as a form of water-proofing. As with the main roof, localised repairs are necessary to a number of the slates in the short term, with more extensive replacement in the longer term. It may prove more economical to replace these at the same time as any major works depending on budget.

Photo 12 - slipping slate

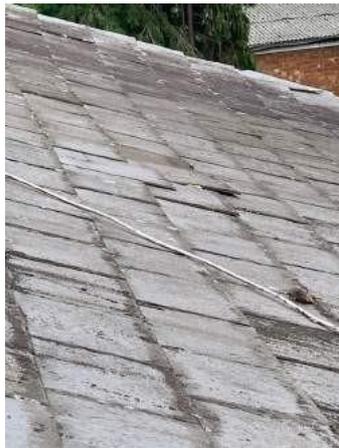
Photo 13 - Slipping slates

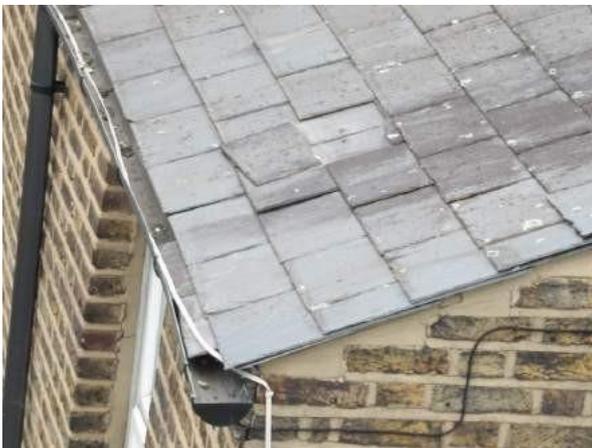
Photo 19 - slipping slates

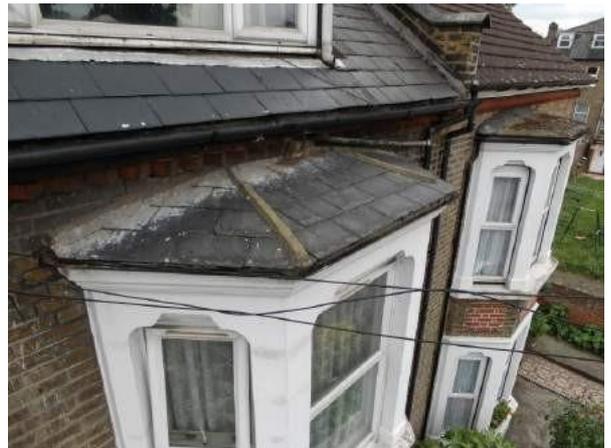
Photo 22 - old front bay roof

The front bay roof is in poor order and we would recommend that this is stripped and replaced with a new lead flashing installed at an approximate cost of £500-£1000.

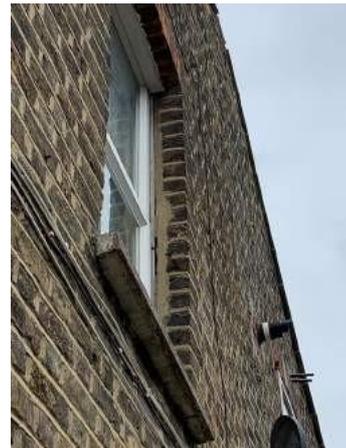
Photo 49 - Bulging brickwork

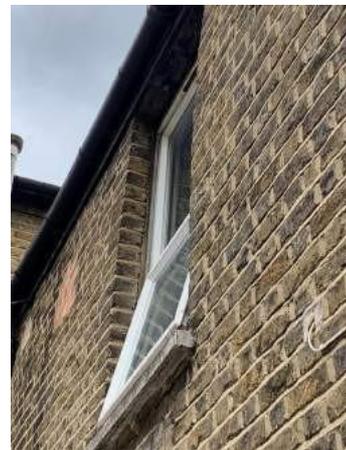
Photo 53

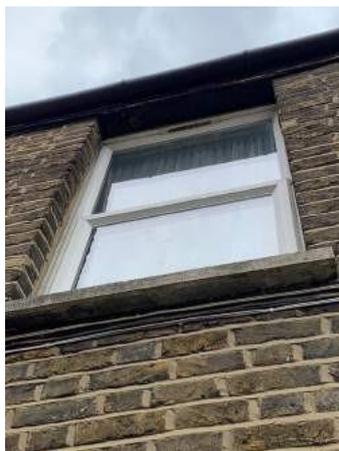
Photo 54 - No lintels

As mentioned previously there is bulging to the brickwork surrounding the rear addition windows and cracking to the brickwork above the rear kitchen and bedroom windows which indicates there is no adequate lintel here. As advised a Structural Engineer should be instructed to specify the repairs.

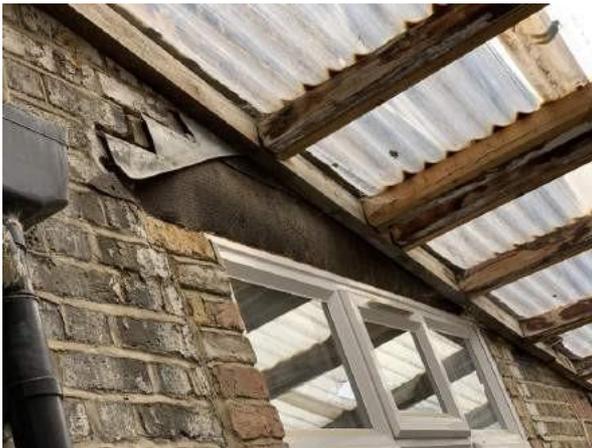
Photo 60 - Exposed section

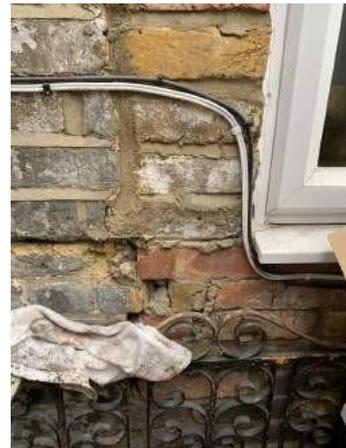
Photo 61 - Poor brickwork

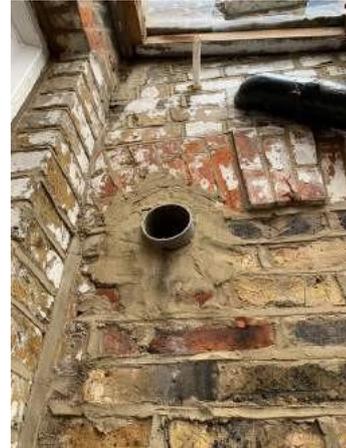
Photo 63 - Exposed vent

There is inadequate sub-floor ventilation to the ground floor and therefore the floor timbers will be vulnerable to damp and decay. The air vents should be uncovered or reinstated to improve the air flow and ventilation.

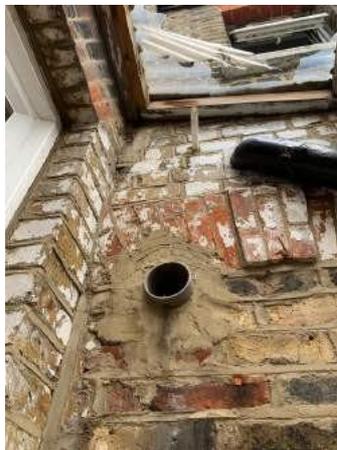
Photo 64 - Untidy brickwork

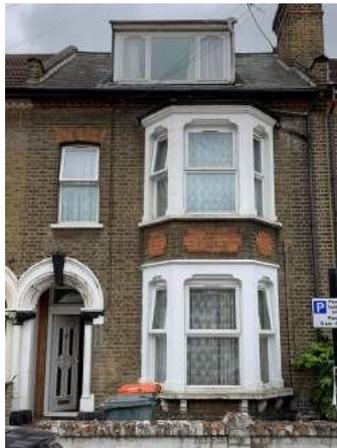
Photo 66

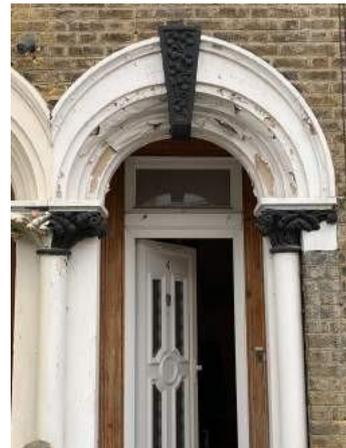
Photo 67 - Peeling paint

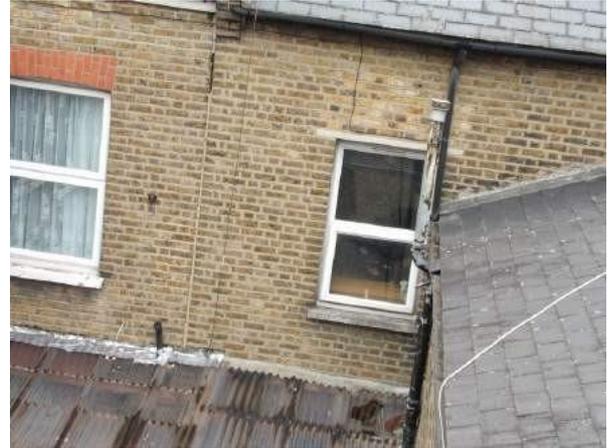
Photo 69

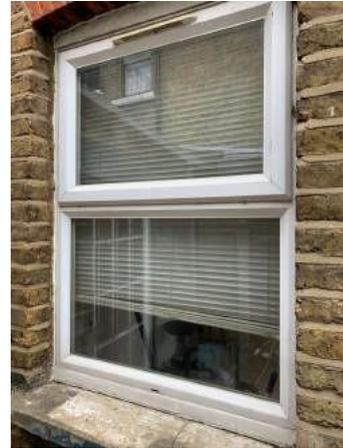
Photo 73

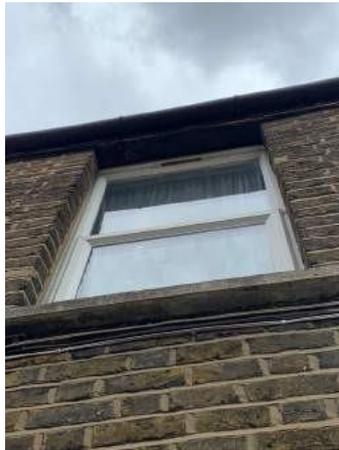
Photo 74 - No lintel

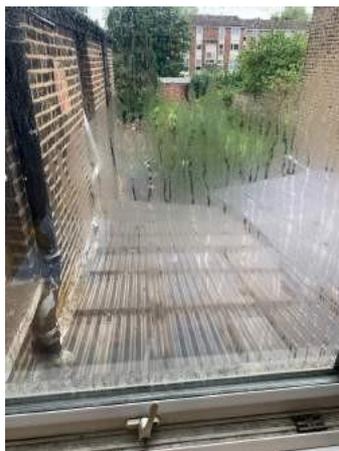
Photo 78 - Misted

Some of the double glazing has misted over notably to the rear middle bedroom. This is the result of the defective seals to the panes allowing condensation to form internally. Where the windows have misted over the panes should be replaced altogether. There are other treatments available such as drilling and inserting warm air between the panes but this only acts as a short term fix.

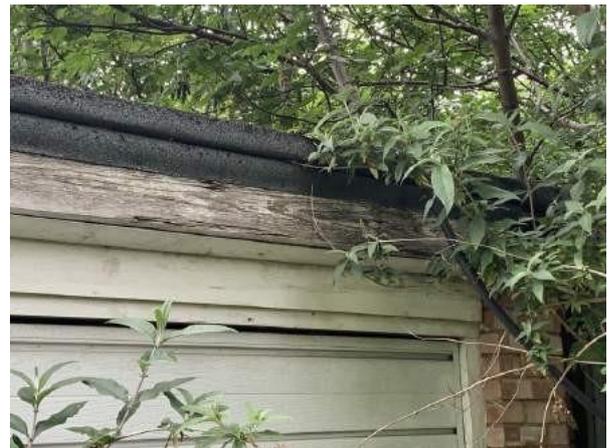
Photo 102 - Rotten joinery

The external joinery is badly weathered and slightly rotten particular to the fascias which should be replaced.

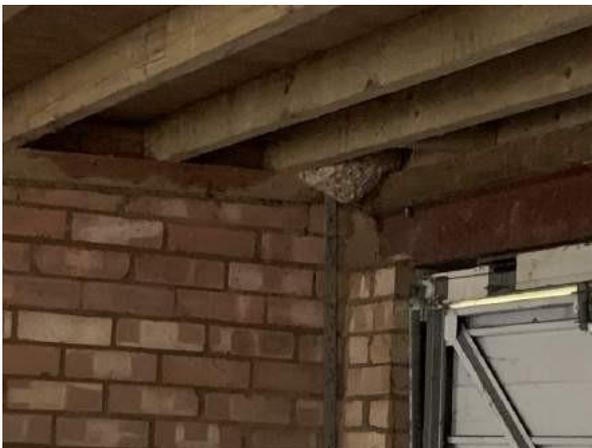
Photo 105 - Wasps nest

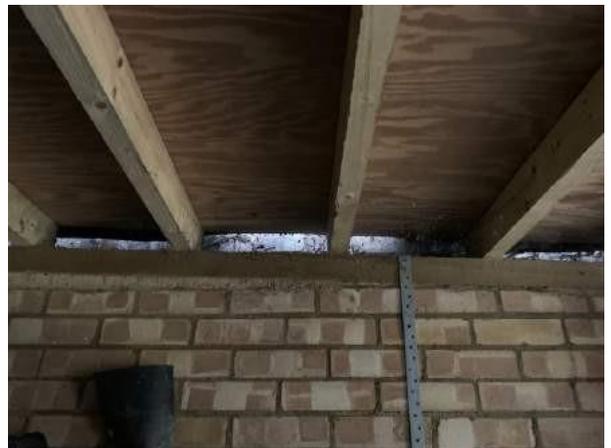
Photo 106 - Gaps

There are gaps along the party wall roofline junction and there should be filled in to prevent any moisture ingress.

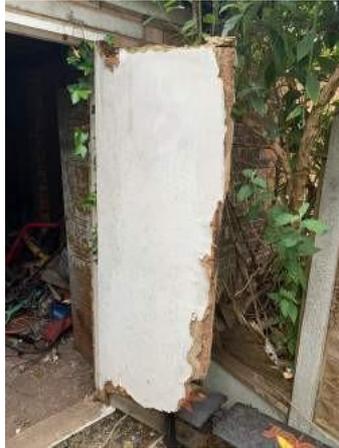
Photo 109 - Rotten door

The entrance door to the garage is rotten and dilapidated and should be replaced.

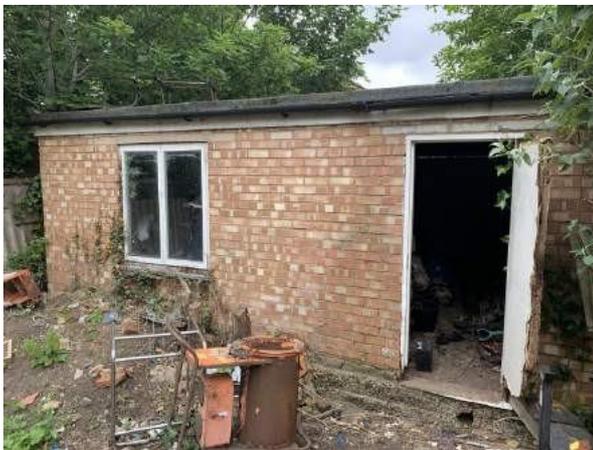
The concrete base foundation is visible and has cracks underneath. We saw no evidence of major cracking of movement to the internal walls and floors and therefore generally believe the foundations to be sound but some repairs may be necessary here.

Photo 112 - Cracks to foundation slab

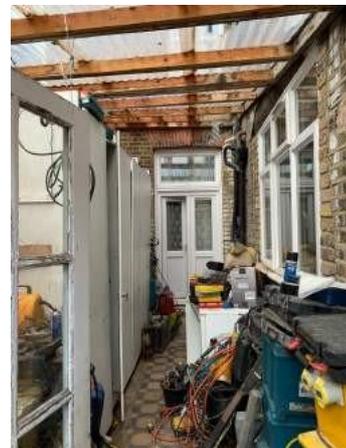
Photo 119 - Rot

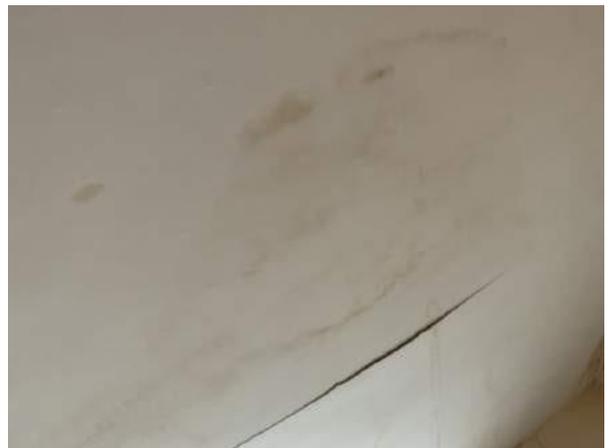
Photo 132 - Cracking to plasterboard

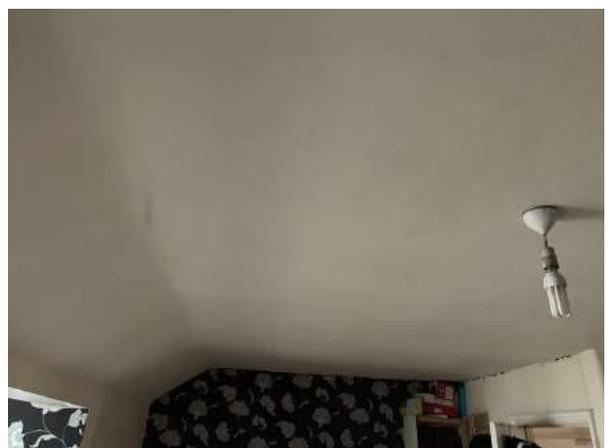
Photo 134 - Old plaster

As with the ceilings, the plaster throughout the property is old, cracked and generally in poor order. The property should be re-plastered as part of the refurbishment works.

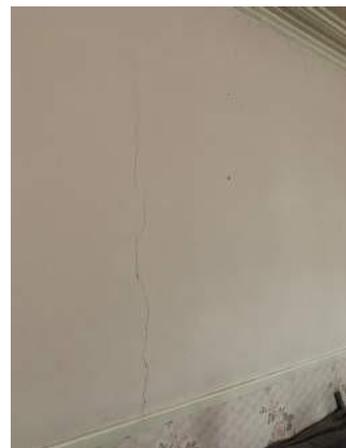
Photo 147 - Cracking above removed partition

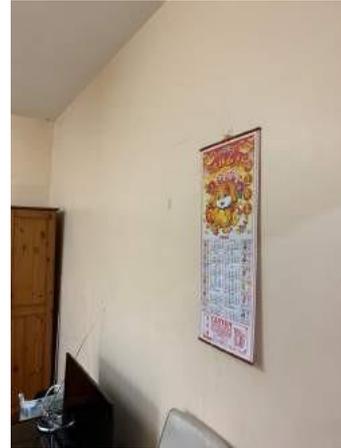
Photo 149 - Significant Cracking

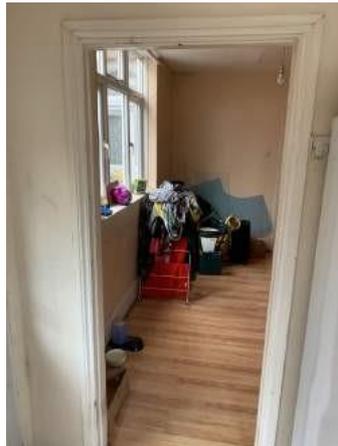
There is no fire door to the kitchen. None of the other doors are of fire resisting construction and although it is not a statutory requirement, we would recommend that you consider fitting fire doors to the kitchen, bedrooms and living room at an approximate cost of £400 each.

Photo 164 - No kitchen door

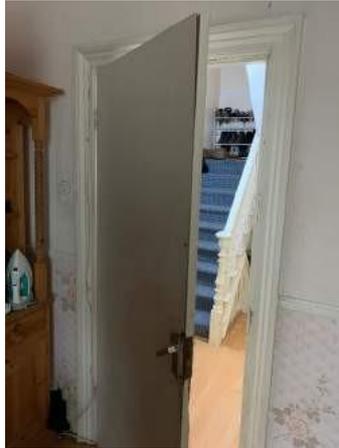
The internal doors are old and ill-fitting. The doors should be replaced .

Photo 168 - Dilapidated door

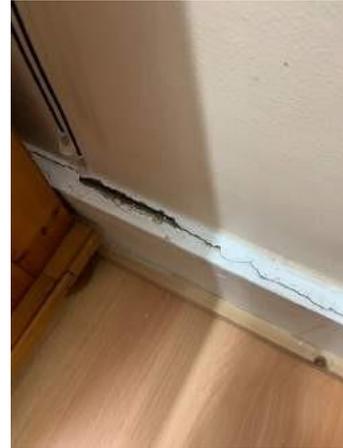
The internal joinery throughout is old, worn and in poor order and we would recommend that this is replaced and refurbished as part of the major works.

Photo 169 - Poor internal joinery

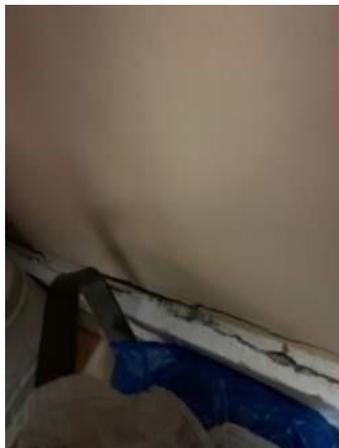
The skirting boards to the middle first floor bedroom are rotten and should be replaced.

Photo 170 - Rotten skirting

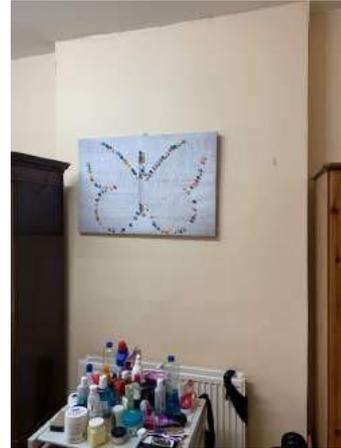
There is an old gas fire to the rear dining room. This appears old and dilapidated and should be removed by a gas safe engineer. We would then recommend that the remaining chimney breast is adequately covered and vented.

Photo 178 - No vent

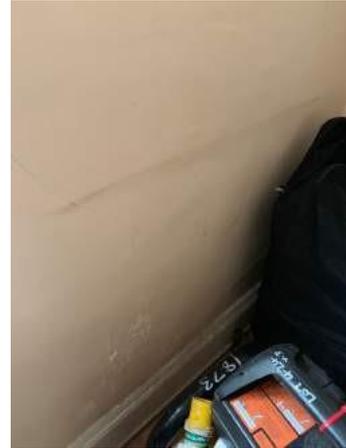
There is extensive damp to the dining room and cloakroom which we suspect is either caused by leaks from the bathroom fittings above which should be inspected by a plumber or the exposed sections where the rear bay has been replaced.

Photo 181 - Damp

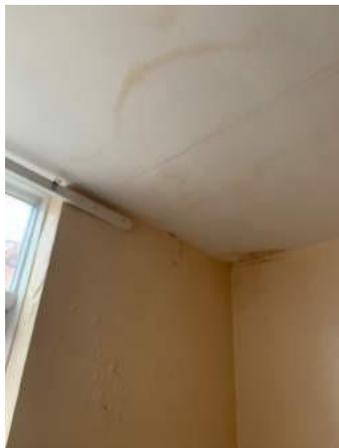
Photo 182 - Damp

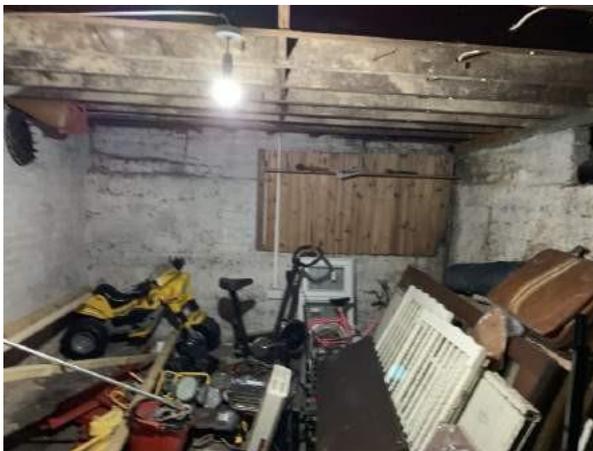
Photo 194

The cellar is rather damp and derelict. Signs of rot, decay and potential wood-boring insect infestation were noted to the timbers in the cellar. The timbers in direct contact with the walls are also rather damp and stained. The floor timbers throughout should be inspected by a qualified PCA damp and timber specialist who should quote for the remedial works required. Given the extensive dampness throughout there is a big risk further damp, decay and possibly wood-boring insect infestation will be found when the floors are exposed. You should be mindful of this risk.

Cellars by their very nature are vulnerable to dampness and the area should be kept well ventilated and only used for the storage of non-perishable goods. If you wish to utilise the cellar further it should be properly tanked and dry-lined.

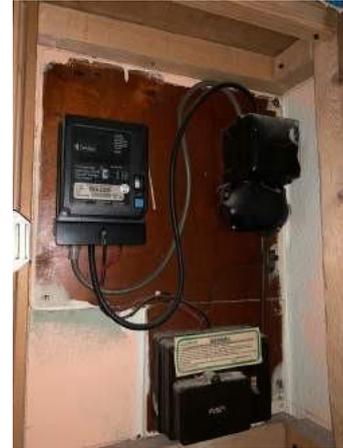
There are various areas of untidy and unsafe exposed cabling which should be rectified immediately.

Photo 204 - Exposed wiring

In the absence of a current electrical test certificate, we would advise you to employ the services of a qualified electrician to inspect and test the wiring and to provide you with a report on its condition together with a quotation for any improvement works found necessary.

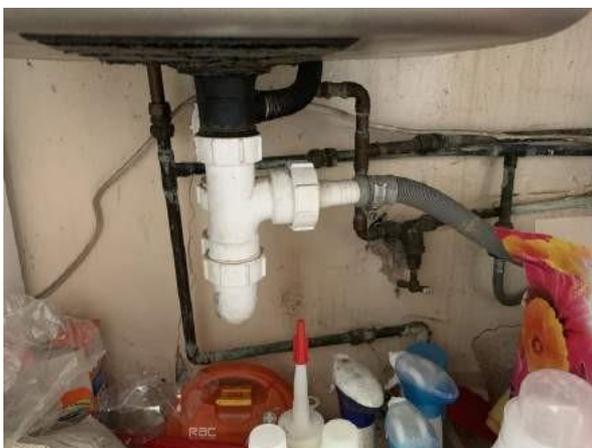
Photo 209

There is leaking pipework which has caused dampness and staining to the dining room and cupboard. A plumber should be instructed to investigate and rectify this. This might have caused rot to the surrounding floors.

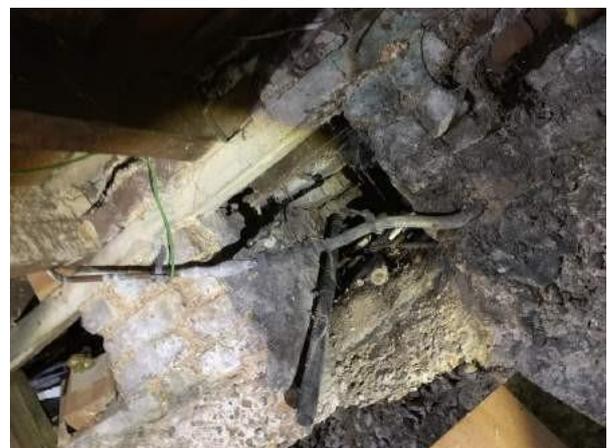
There appeared to be some of the original lead pipework remaining. You should contact the water supplier to test the lead content of the water. If high levels are found the pipework should be replaced.

Photo 210 - Lead pipe and stopcock

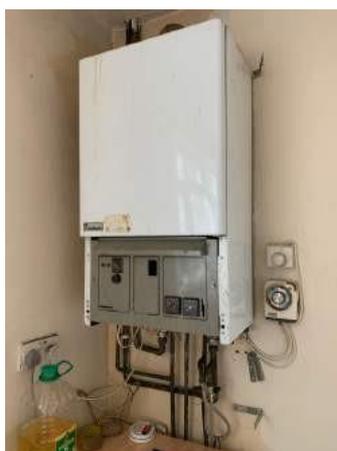
The boiler appears to be rather old and slightly dilapidated. We cannot comment upon its working order. We would recommend that this is replaced with a more modern efficient unit.

Photo 211 - Old boiler

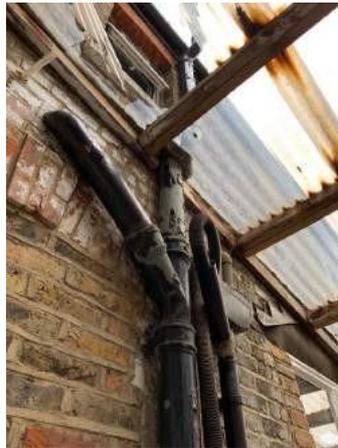
Photo 213

The soil vent pipe is old, badly weathered and has a number of leaking joints.

The plastic drainage pipes to the rear of the property are also in poor order with a number of leaking joints and we would recommend that these are replaced and the gully re-lined.

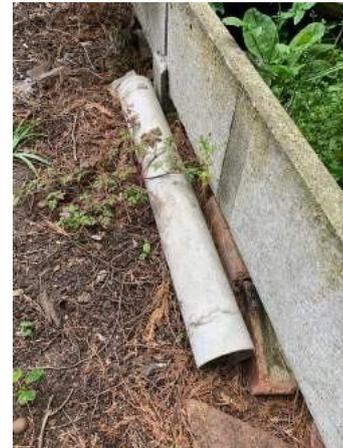
We found discarded asbestos sheets and a pipe to the rear garden and they should be removed by a licensed asbestos specialist.

Photo 220 - Asbestos pipe
