RICS Home Surveys
Survey level two:
HomeBuyer report
- Survey

Example Property

25th July 2019

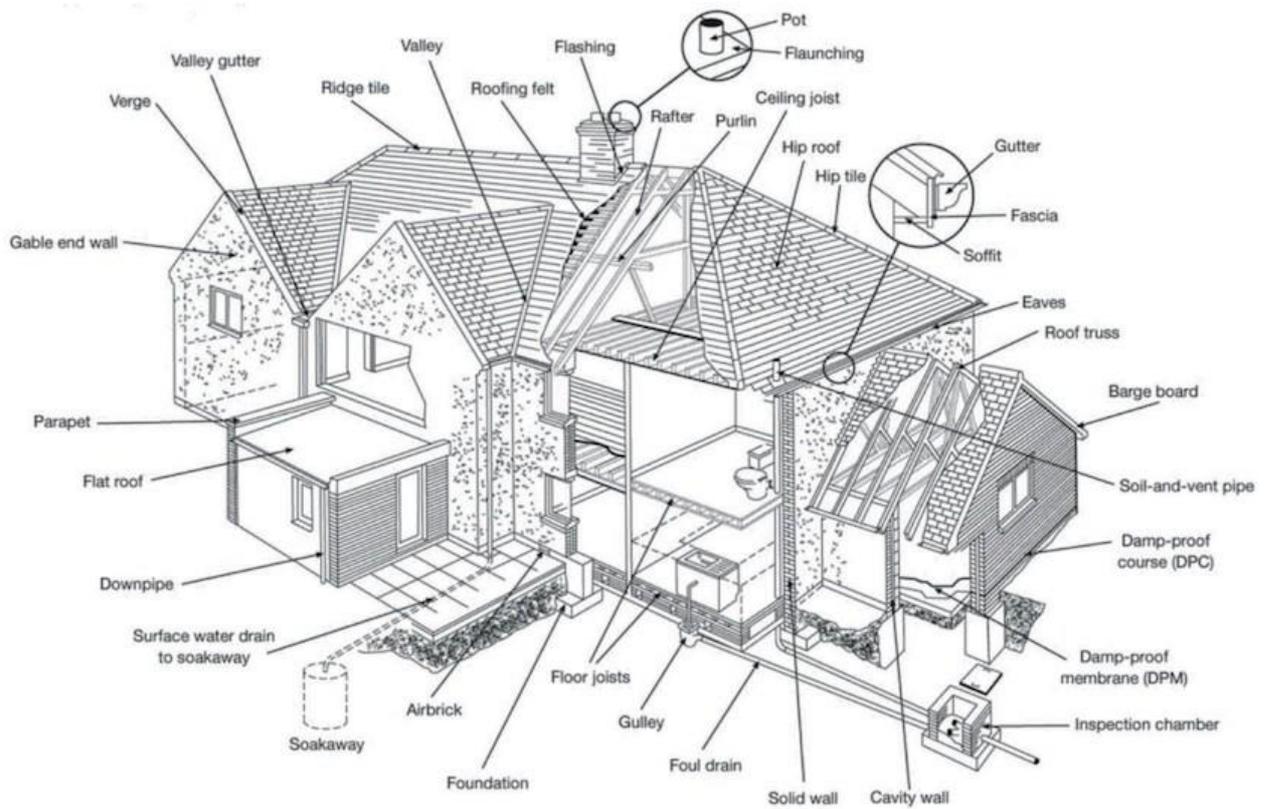
Typical house diagram

This diagram illustrates where you may find some of the building elements referred to in the report.
